**SAMPLE**  
**PROPERTY INSPECTION REPORT**

**Concerning: 4545 Somestreet, Anywhere, TX 760XX**

**By: Dale Miller, Professional TREC # 9126**

**Date: XX/XX/2007**

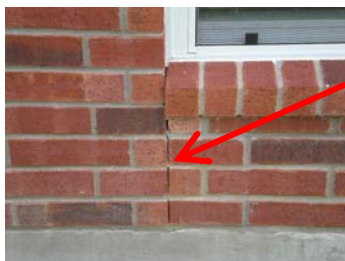
- Exterior: Differential movement/settlement observed. Indicated by one or more of the following observed condition: Cracks in brick veneer.

- Exterior: Expansion joint(s) in brick veneer need caulking. Ensure any mortar present in expansion joint is first removed before sealing.
- Front Entry: Small hole behind front door where door stop penetrated the sheetrock.
- Front Right Bedroom: Nail pops observed on wall. These are typically caused by the studs behind the drywall shrinking.
